# Manhole Inspection Summary

Manhole # S17S\_\_010MH

Insp Date: **6/26/08 11:49 AM**

**Location** Address: **2730 wilmarco av**

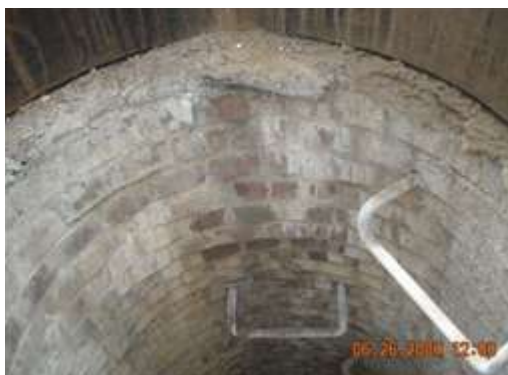
Defect 2

Condition: ☐ Sound ☐ Cracked ☐ Root Intrusion ☐ Loose Brick ☒ **Deteriorated**

Infiltration: ☐ None ☒ **Joint** ☐ Cracks ☐ Mortar ☐ Roots ☐ Wall

chimney cond deteriorated, infiltration @ chimney/frame joint

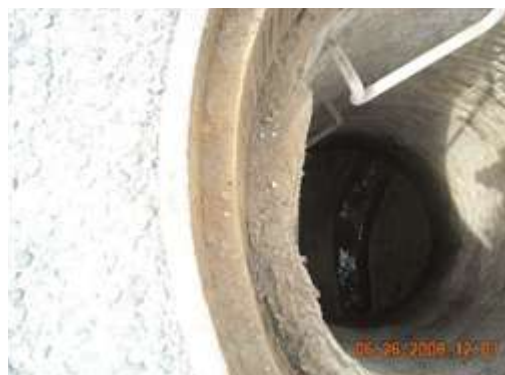
Defect 1

Offset: **1** (in.)

frame offset

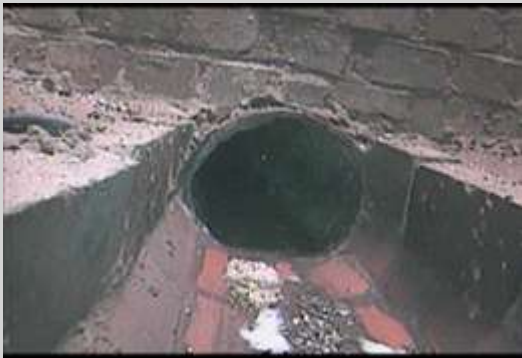
12 O'Clock Outflow

8 in. Circular Gravity Sewer  
Pipe Out @ 12 O'Clock

Pipe Height: **8.4** (in.) Rod and Bar (Angled)  
Pipe Material: **Clay** ☐ Pipe Lined  
Invert Depth: **11.92** (ft.) Flow Characteristics: **Slow**  
Deposits: ☒ None ☐ Mud ☐ Sludge ☐ Debris ☐ Grease  
Silt Depth: **0** (in.) Deposits Extent:  
Infiltration: **None** Pipe Seal Cond: **Sound**

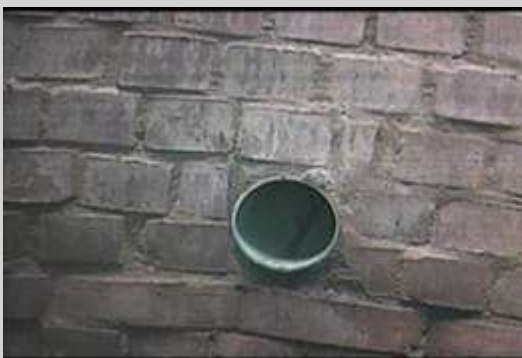
7 O'Clock Inflow

4 in. Circular Gravity Sewer  
Pipe In @ 7 O'Clock

Pipe Height: **4.8** (in.) Rod and Bar (Angled)  
Pipe Material: **PVC** ☐ Pipe Lined  
Invert Depth: **8.62** (ft.) Flow Characteristics: **Fast**  
Deposits: ☒ None ☐ Mud ☐ Sludge ☐ Debris ☐ Grease  
Silt Depth: **0** (in.) Deposits Extent:  
Infiltration: **None** Pipe Seal Cond: **Sound**

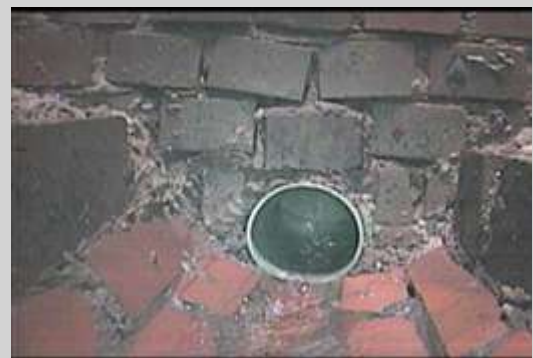
Drop In @ 7 O'Clock

Drop: **Outside** Rod and Bar  
Angled: **Yes** Reading: **10.75** (ft.)  
Inv Depth: **11.75** (ft.)  
Drop Condition: **Open**
